## CHAPTER 2. MEDICAL EQUIPMENT MAINTENANCE INFORMATION

### 2-1. ACT 10 BLOOD ANALYZER, 6630-01-468-9142 (BECKMAN COULTER)

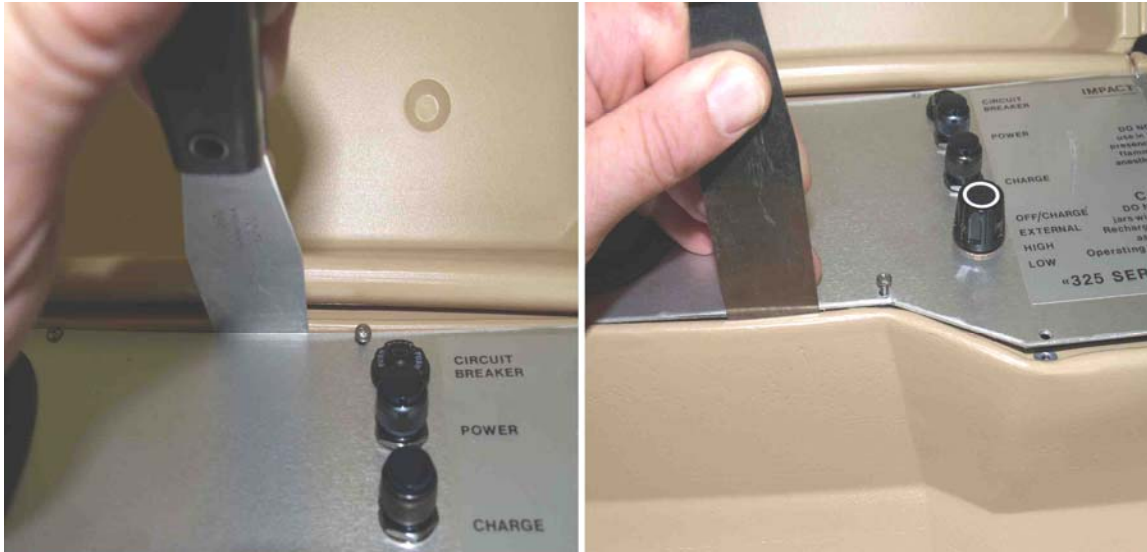
b. Another concern to be aware of when servicing this suction apparatus are the small Phillips screws which strip easily when turning them back in to reattach the unit plate. Utilizing a flat-bladed device to manipulate and position the flexible plastic molding will align the thread-hole concentric to the screw and allow successful reassembly. This precautionary procedure will prevent an otherwise good unit from being removed from mission capable status because of a damaged case. (See photos below)

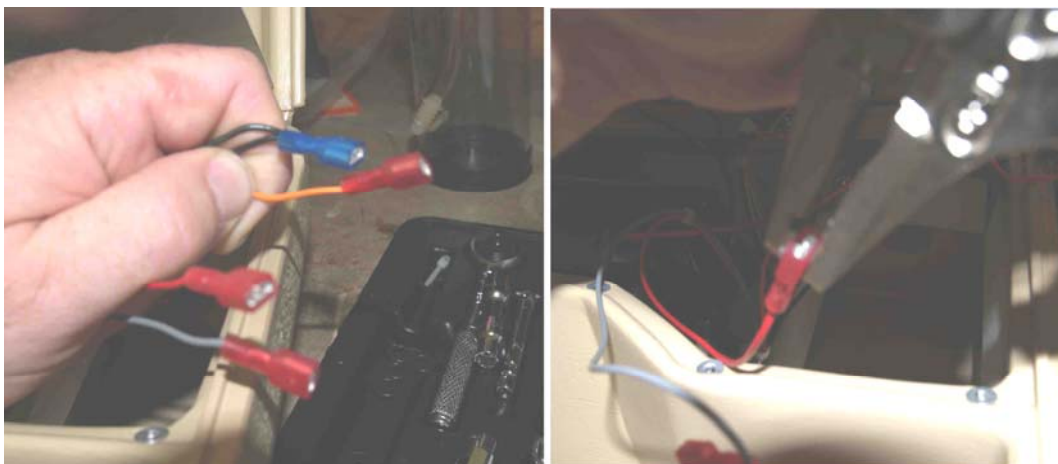
c. Another frequent occurrence with the 325M happens when the operator turns the dial switch and the pump motor does not initiate. Sometimes the motor will engage between dial increment settings only. Most often the cause is the contact surface adjoining the yellow wire. It either has twisted and needs careful realignment and crimping, or the electrical path has been broken and the switch needs repair or replacement. See photos below.

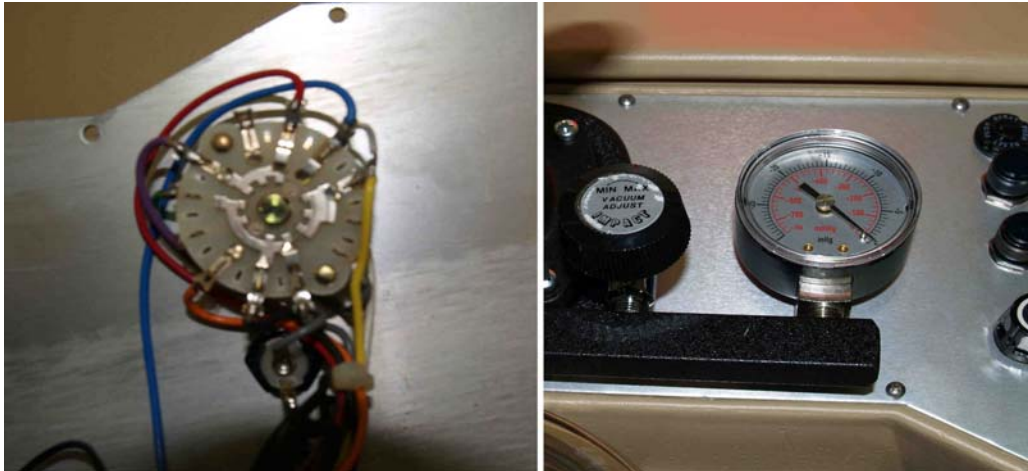
d. Packaging the manual(s) or hose-tubing container inside the lid of the suction unit causes downward pressure to be applied against the moveable arm mechanism to which the gauge is attached. This forces the right corner of the gauge housing to jam against the unit plate. The internal mechanism of the pressure gauge moves independently of the housing, rendering the gauge damaged which requires replacement. See photos below.
